# **Technologies for Seismic Retrofitting and Strengthening of Earthen and Masonry Structures: Assessment and Application**

**Paulo B. Lourenço**

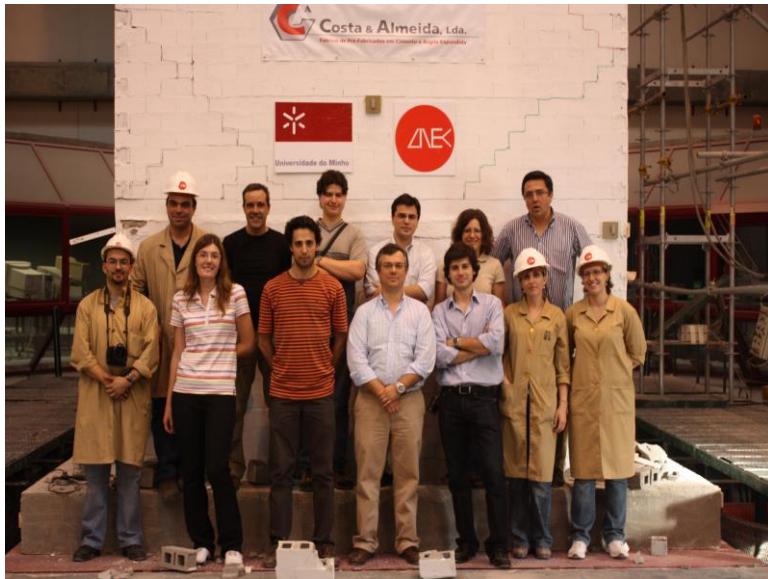
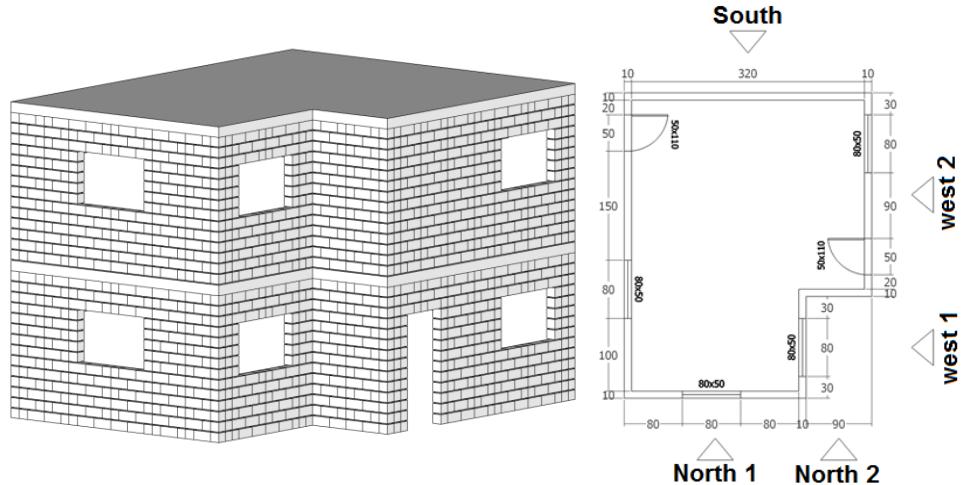
## Modern masonry as good as other building technology

- Worst case scenario in masonry: embedded ring beam + unfilled vertical joints
- Light damage up to the design earthquake in Lisbon (rock)
- Ductile damage for 2.5x the design earthquake in Lisbon (rock),  $q = 2.5$

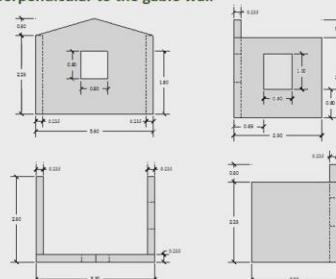
## Structure with clay-unit masonry and English bond

- Unreinforced gable wall and return walls on both ends
- Perforated bricks and cement-based mortar
- An opening in one of the returning walls, resulting in an asymmetry, and consequently, inducing torsional movements
- Thickness of the walls equal to 0.235 m
- Unidirectional seismic action perpendicular to the gable wall

- ❑ 17 predictions. Estimated PGA at collapse: 0.30-1.00 g (COV=39%)
- ❑ Experimental result (1.27 g). Average PGA of predictions: 0.64 g. All predictions lower than experimental results
- ❑ Problems: slenderness of the structure, torsional effects, material properties?

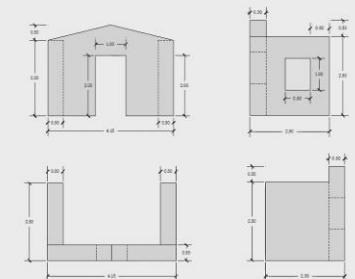
## Structure with stone masonry units

- Unreinforced gable wall and return walls on both ends
- Stone units and lime-based mortar
- An opening in one of the returning walls, resulting in an asymmetry, and consequently, inducing torsional movements
- Thickness of the walls equal to 0.50 m
- Unidirectional seismic action perpendicular to the gable wall

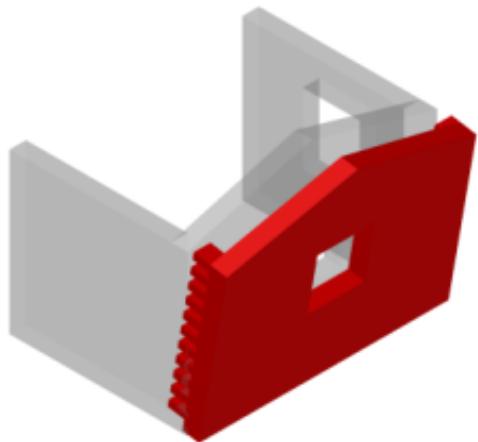
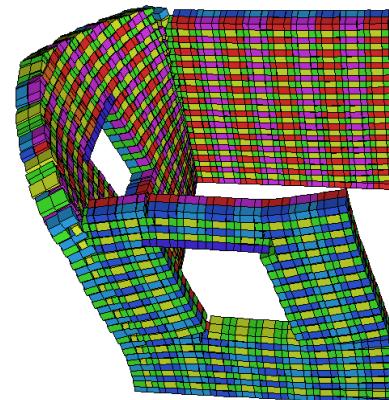
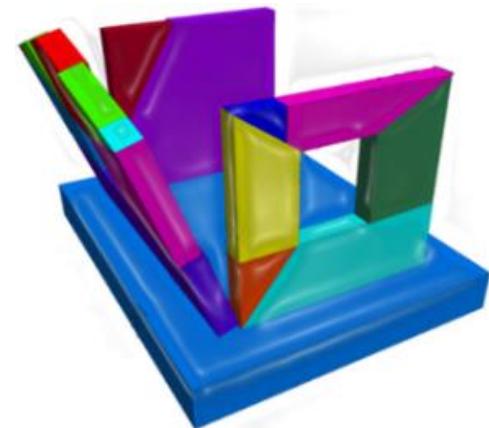
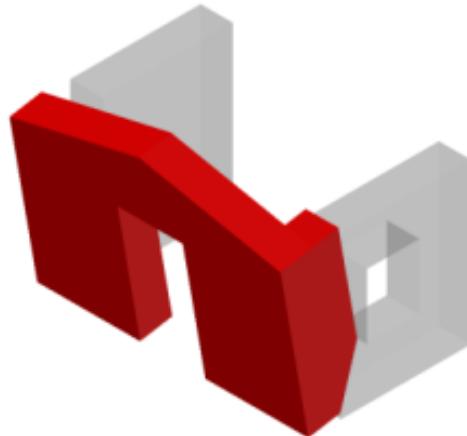
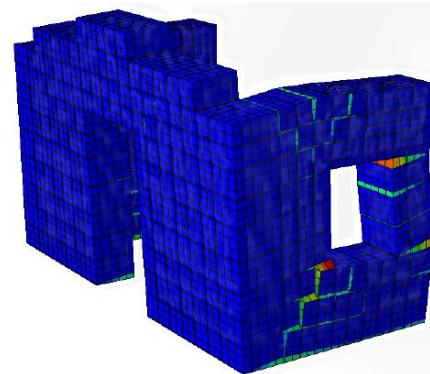
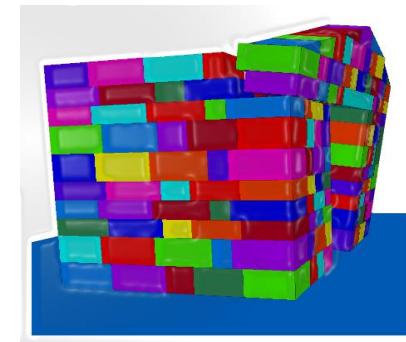
## Examples of models adopted by experts

- Geometry
- Material properties (specific mass, Young's modulus, tensile and compressive strength)
- Normalized accelerogram envelopes of the seismic action applied at the base, and the corresponding response spectra
- Modelling approaches adopted:
  - rigid macro-blocks (23 models)
  - finite element modeling (7 macro-models, 3 micro-models)
  - discrete element method (3 meso-models)
- Type of structural analysis:
  - Limit analysis based on the kinematic approach;
  - Static non-linear analysis (pushover), usually mass (a few first mode) proportional
  - Non-linear dynamic analysis with time integration, with artificial accelerograms applied at the base of structures generated by the experts

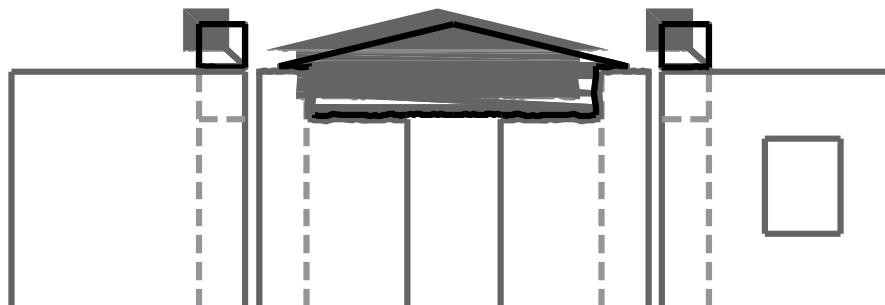
Mechanisms 1-4

- Estimated PGA at collapse ranged from 0.22-2.50 g (COV=63%)
- Average estimated PGA of 0.91 g (Experimental equal to 1.07 g)
- Large variance due to incorrect prediction of collapse mechanism. For mechanisms similar to test, prediction range was 0.53-1.42 g (COV= 31%)

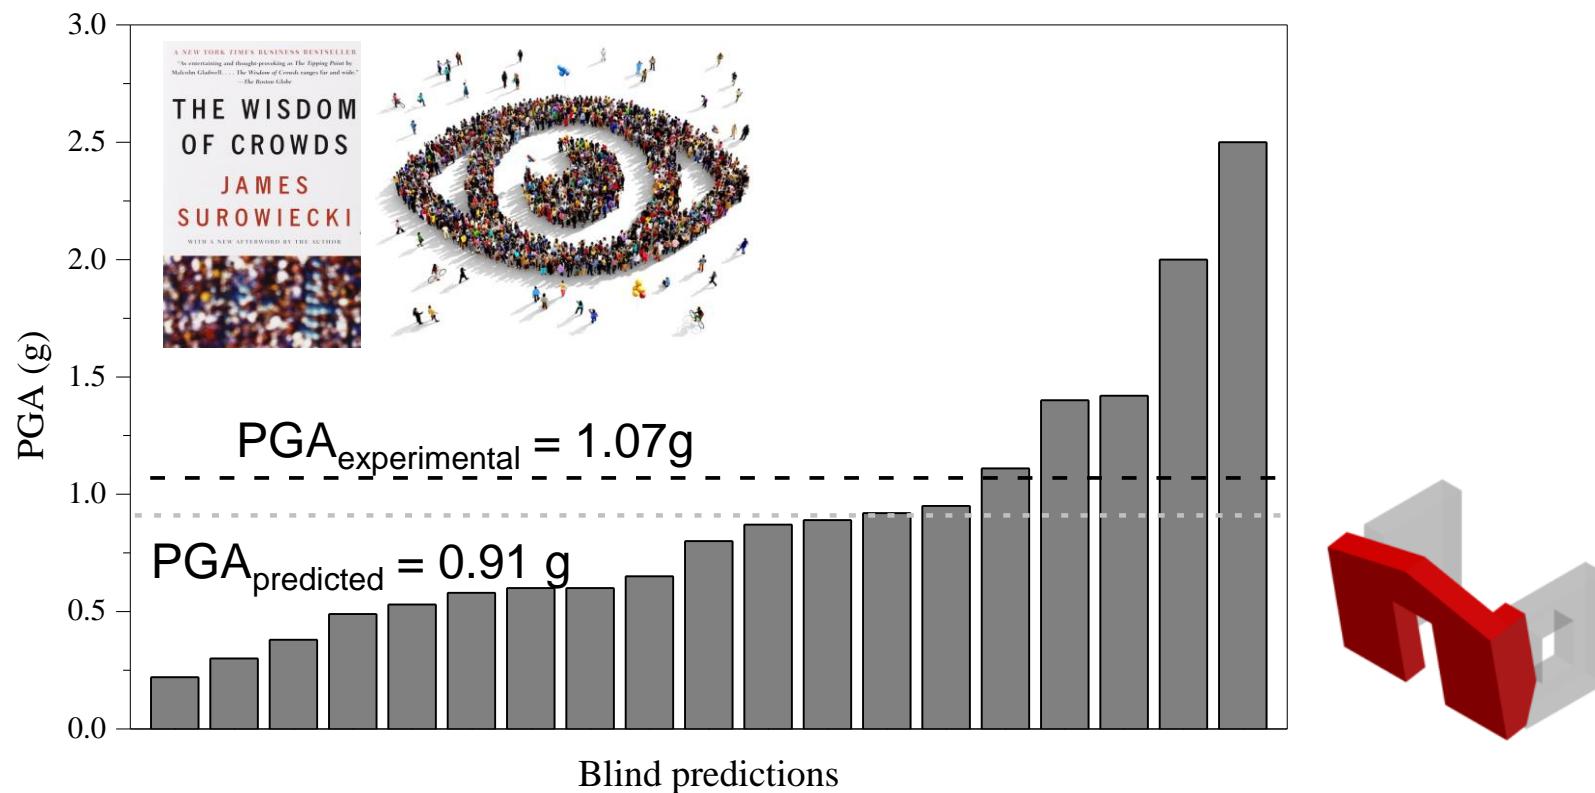
## Stone building: 13 idealized collapse mechanism proposed (II)

- Average error between test and predicted PGA for good mech. was 28%
- 80% presented a predicted PGA lower than or equal to test
- Within good mech., two results presented collapse displacement at top (0.16 and 0.25 m). Test provided 0.22 m (about half of the wall thickness).

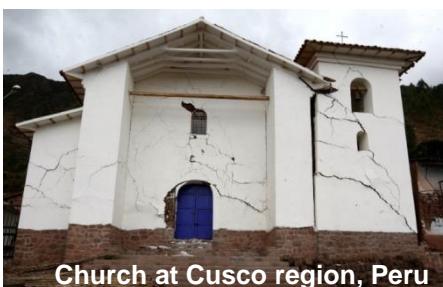
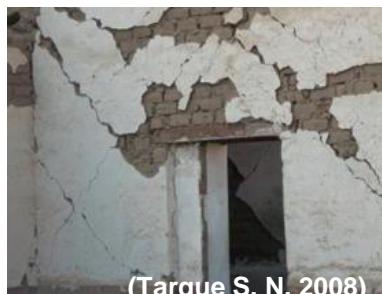
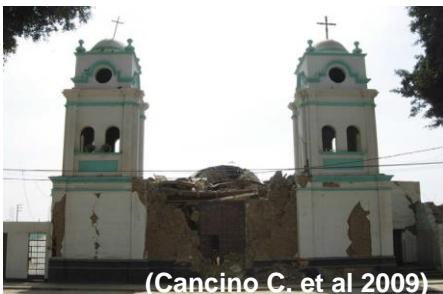
- Poor mechanical properties
- Lack of lateral confinement
- Lack of maintenance

Church at Cusco region, Peru

Rocking of independent structural parts. In-plane diagonal and horizontal shear cracks.	Shear cracks due to pounding between orthogonal walls.	Pediment overturning in gable-end walls.

Gable-end wall overturning and possible toe crushing at base.	Diagonal shear cracks in transversal walls. Gable-end wall overturning with portions of transversal walls.	Shear failure and sliding of peripheral bracing.

Diagonal tensile cracks from out-of-plane bending. Diagonal shear cracks in transversal walls.	Separation and overturning of small wall segments.	Separation and overturning of large wall segments.

In plane shear cracks near openings and masonry piers.	Corner dislocation and overturning.	Partial disintegration and loss of structural material.

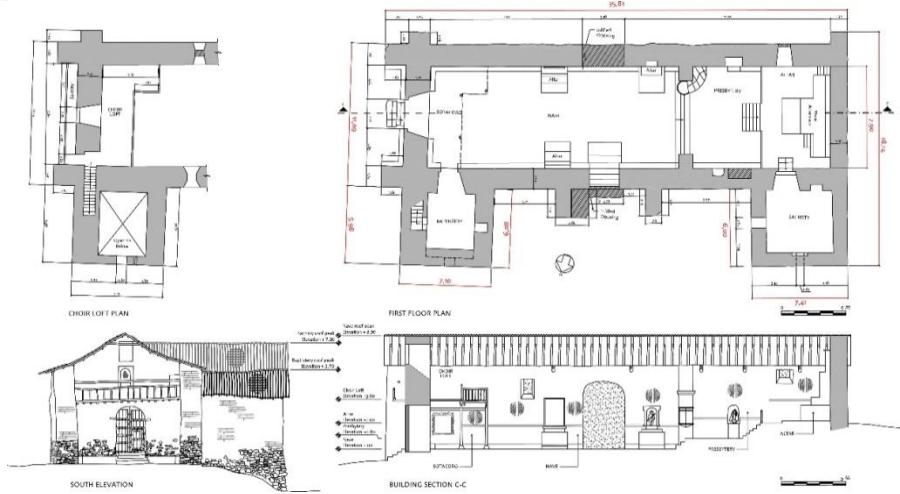
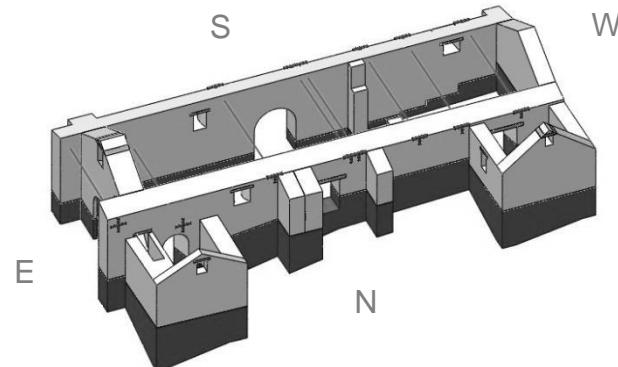
# Church of Kuño Tambo (KT)

- Built in **17<sup>th</sup> century**

- **Structure**

- Single nave with a sacristy and a baptistery
- Adobe walls with rubble stone base course
- Buttresses
- Single gable timber roof
- Timber ties and wall plates

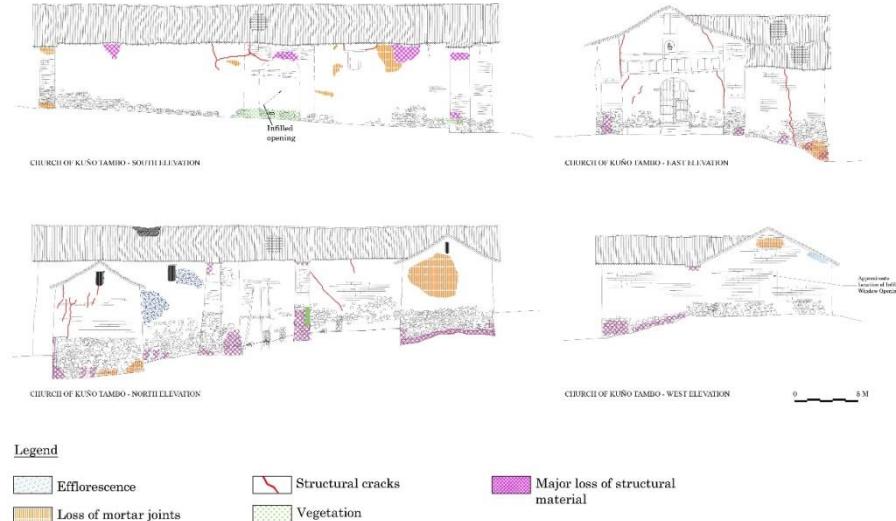
## □ Damage

- Vertical cracks
- Loss of material
- Deterioration

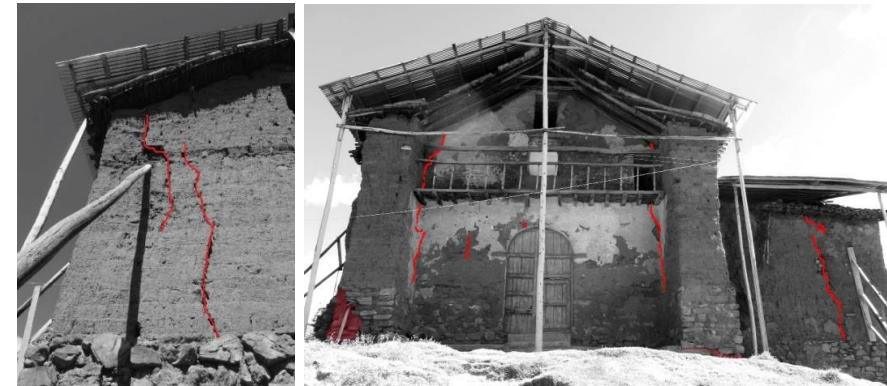
## □ Diagnosis

- Earthquakes
- Settlements
- Lack of maintenance

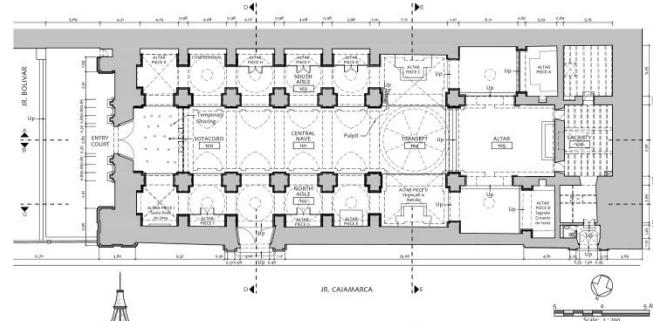
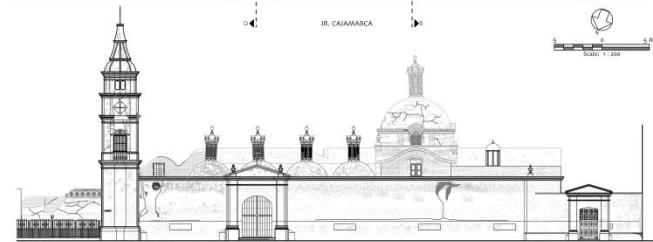
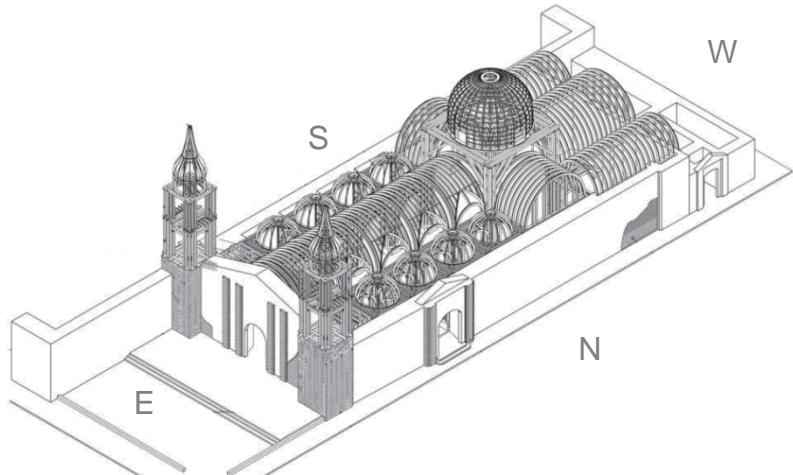
## Ica Cathedral (IC)

- Built in **18<sup>th</sup> century**, national monument since 1982

- **Structure**

- External masonry envelope (rubble stone, fired brick, rubble stone)
- Internal timber frame (*quincha* technique)

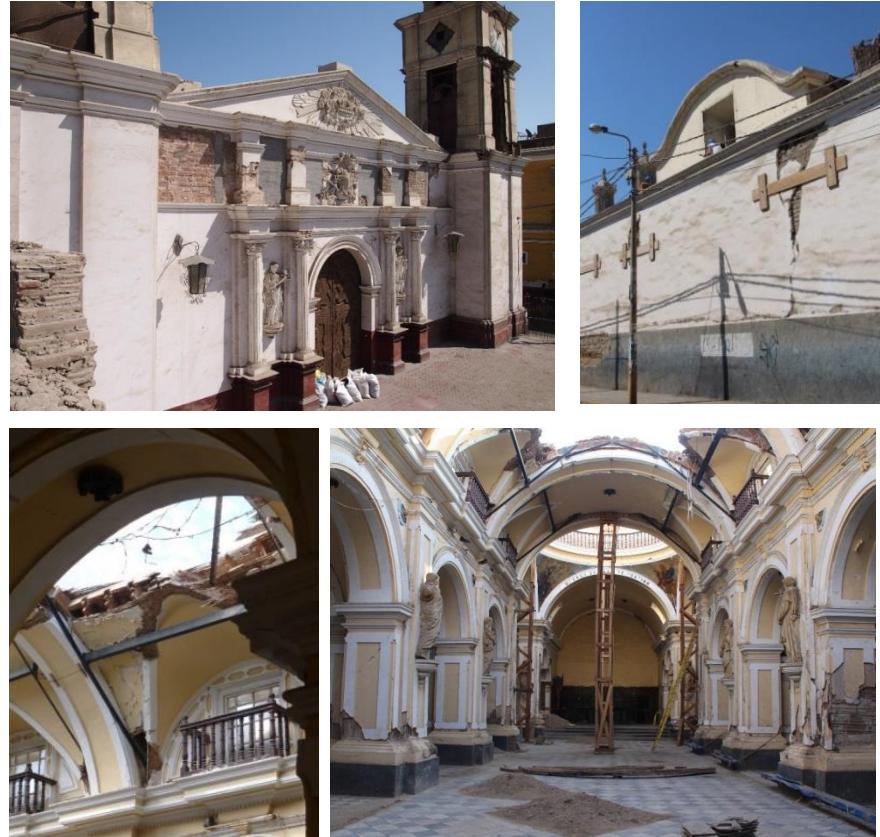
### Damage

- Collapse of the roof system
- Vertical cracks
- Loss of material
- Deterioration

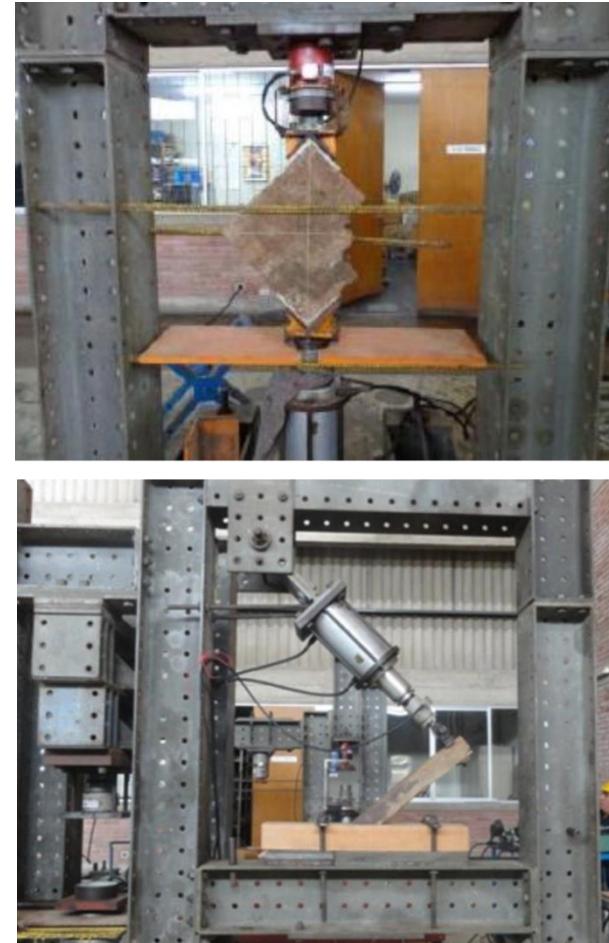
Laboratory tests performed by PUCP

- **Material properties**
- **Behaviour of traditional structural systems**
- **Tests**
  - Adobe, brick, timber and lime mortar
  - Adobe and brick masonry
  - *Quincha* panels and timber connections
  - Traditional strengthening techniques

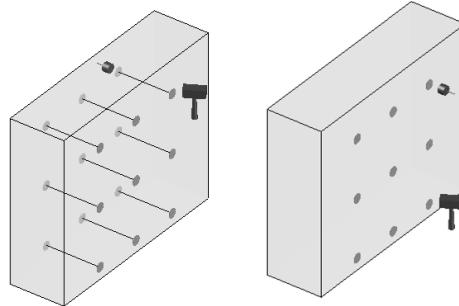
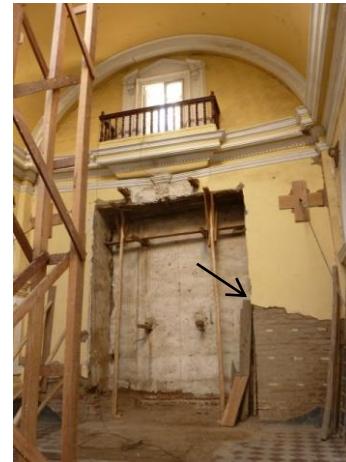
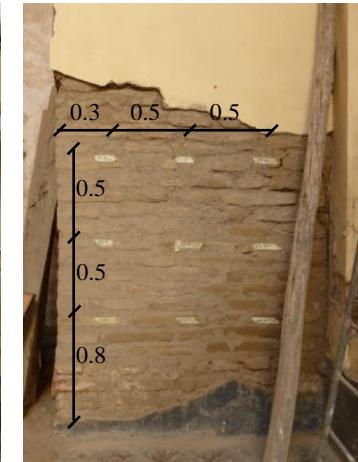
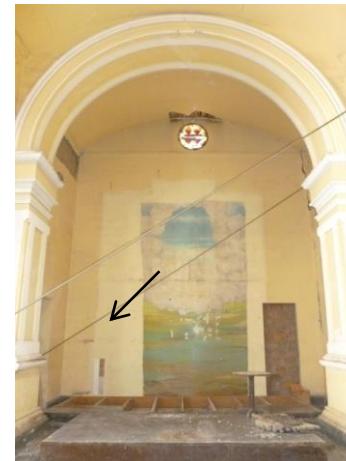
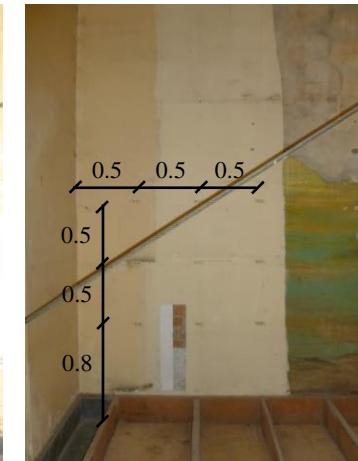
Sonic tests performed by UMinho

- Morphology
- Mechanical properties
- Tests
  - Direct tests
  - Indirect tests

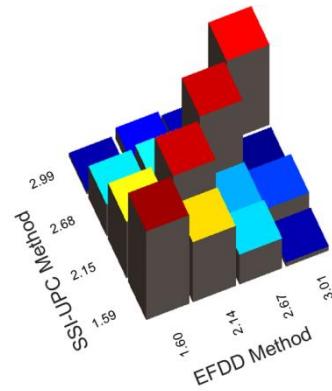
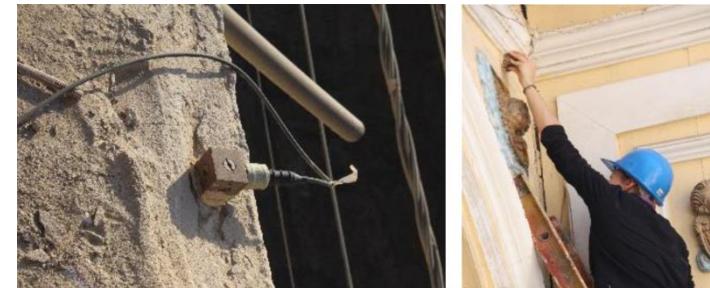
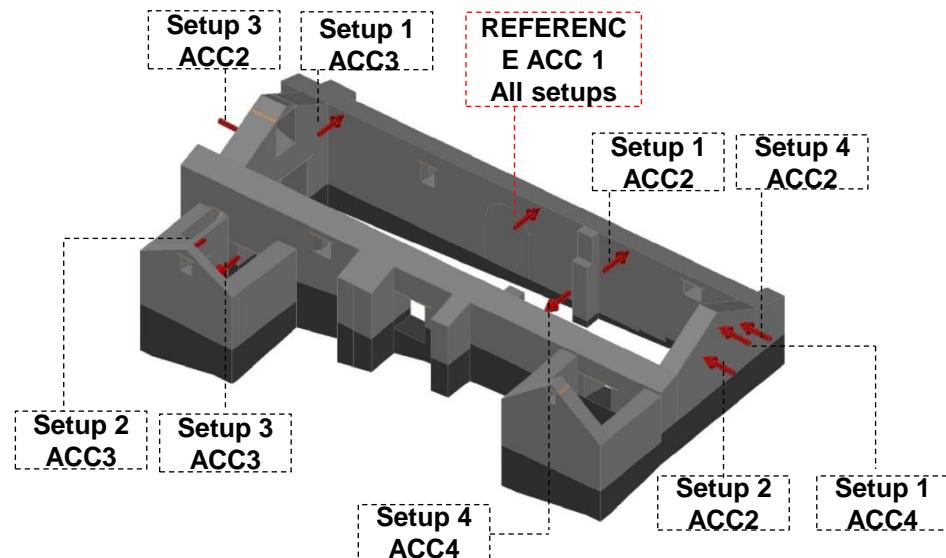
Dynamic identification tests performed by UMinho

- **Dynamic characteristics**
- **Calibration of the numerical models**
- **Test**
  - Output-only (or ambient vibration) technique during service conditions

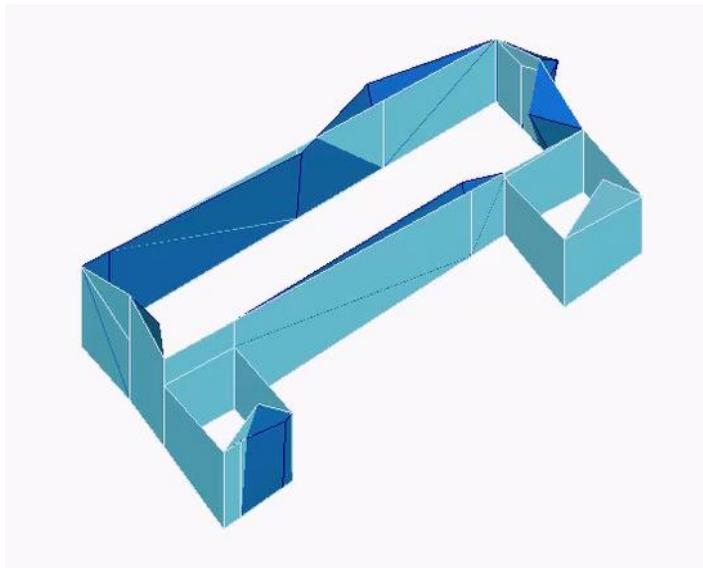
- **Church of Kuño Tambo**
  - Poor connection at the corners
  - Ineffectiveness of the existing tie beams

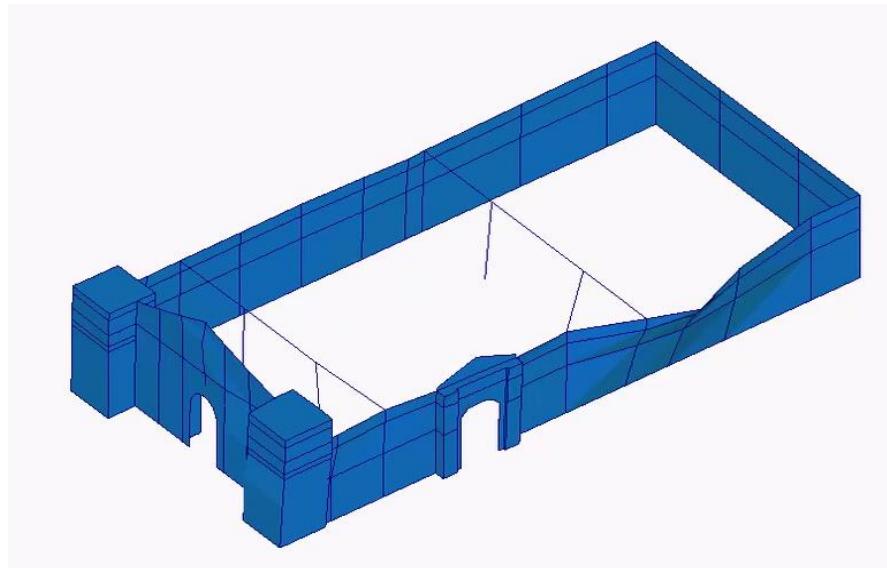
- **Ica Cathedral**
  - Poor connection between the masonry and timber substructures

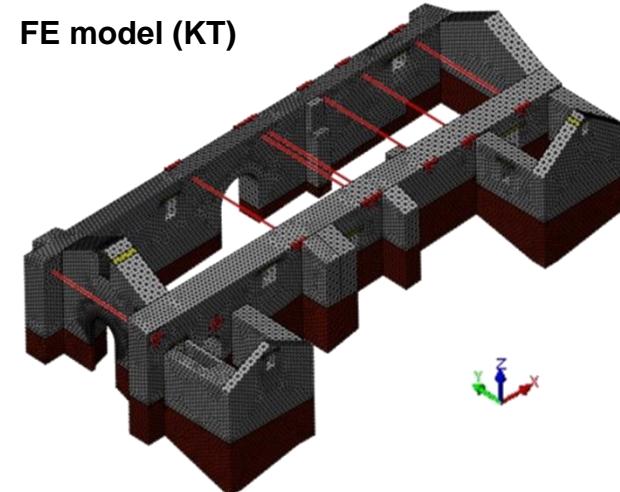
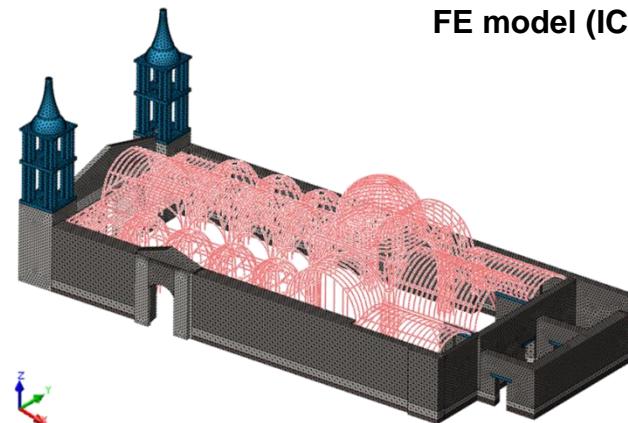
# Finite Element (FE) modelling

- 3D macro-modeling FE approach
- Partial and global models
- Models created in Midas FX+ for DIANA software

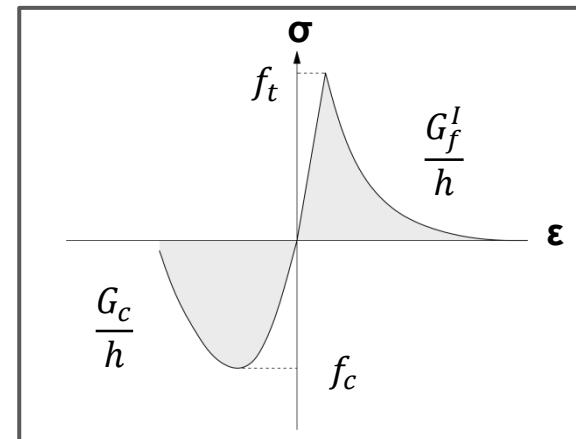
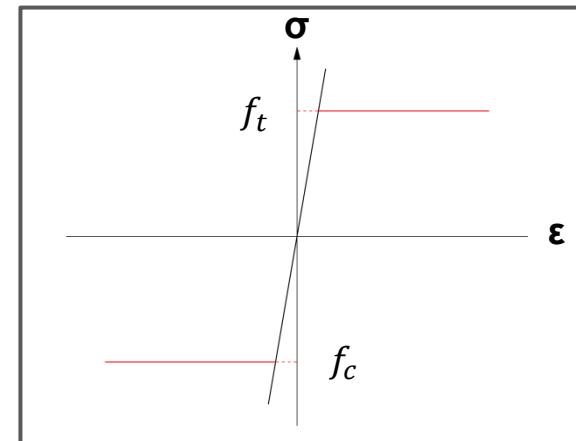
# Material properties and mechanical characterization

- Use of **building standards codes** (e.g. EC6, NTC 2008, RNE 2006) and results from **tests**
- Masonry**
  - Nonlinear behaviour (Total Strain Rotating Crack Model)
- Timber**
  - Isotropic homogeneous and linear elastic behaviour
  - Von Mises criterion

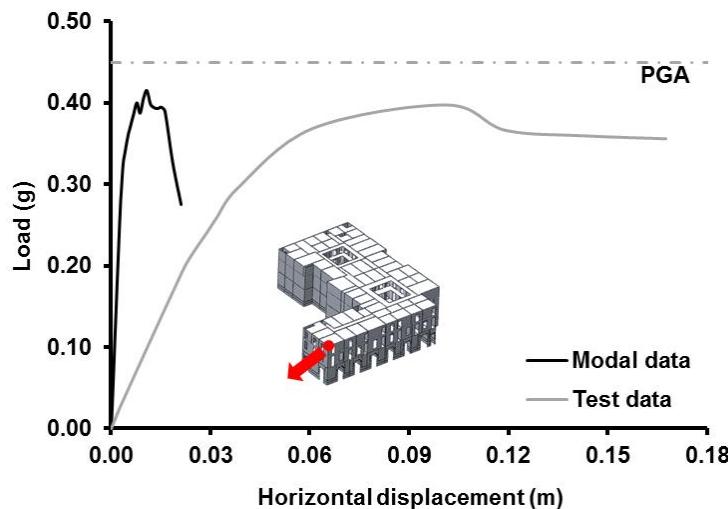
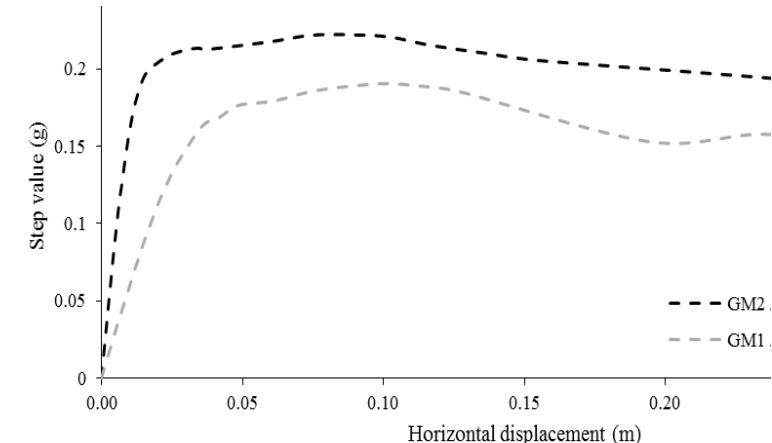
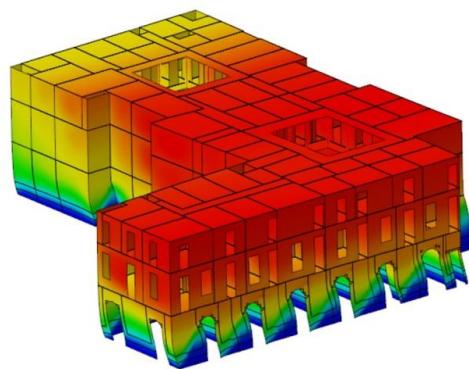
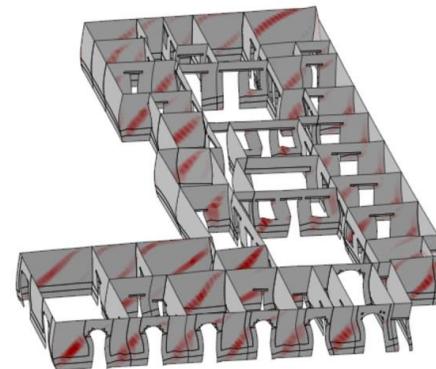
Hotel El Comercio (5% difference)

- The safety structures of historical masonry structures is usually geometry controlled, meaning that material properties tend to have a moderated influence on force based assessment
- Elastic properties were surprisingly complex to estimate and this affects to a great extent deformation response
  - Adobe masonry:
    - Tests in literature.  $E = 30$  to  $200$  MPa
    - Tests with actual materials.  $E = 70$  to  $100$  MPa
    - Sonic testing & dynamic identification.  $E = 250$  to  $300$  MPa
  - Quincha walls:
    - Tests with actual materials.  $E = 50$  MPa (no plaster)
    - Dynamic identification.  $E = 3000$ - $4000$  MPa (different levels)

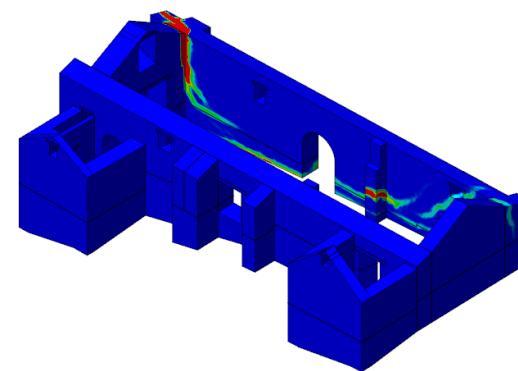
Church Kuño Tambo (15% difference)

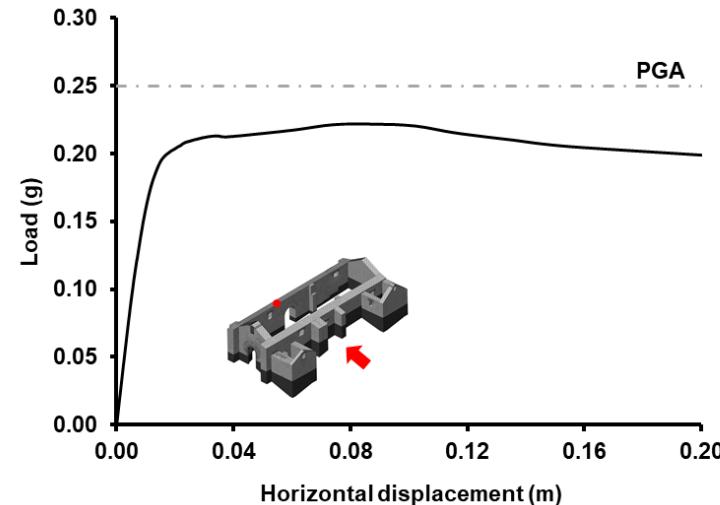
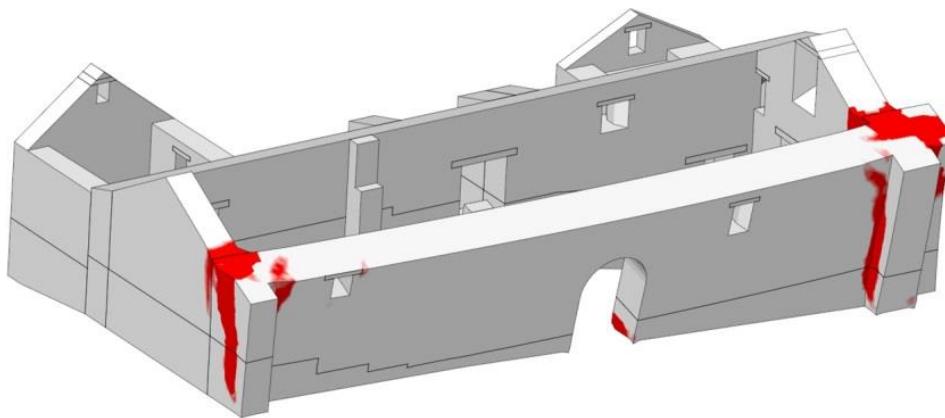
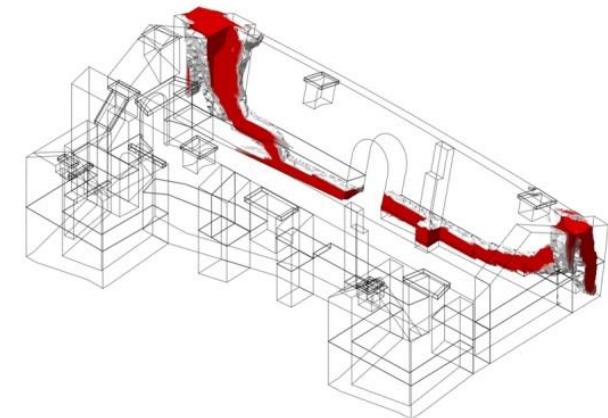
## Pushover analysis (KT)

- Minimum seismic capacity of **0.20g**, lower than the design PGA (0.25g)
- Out-of-plane overturning of the **southern lateral wall**

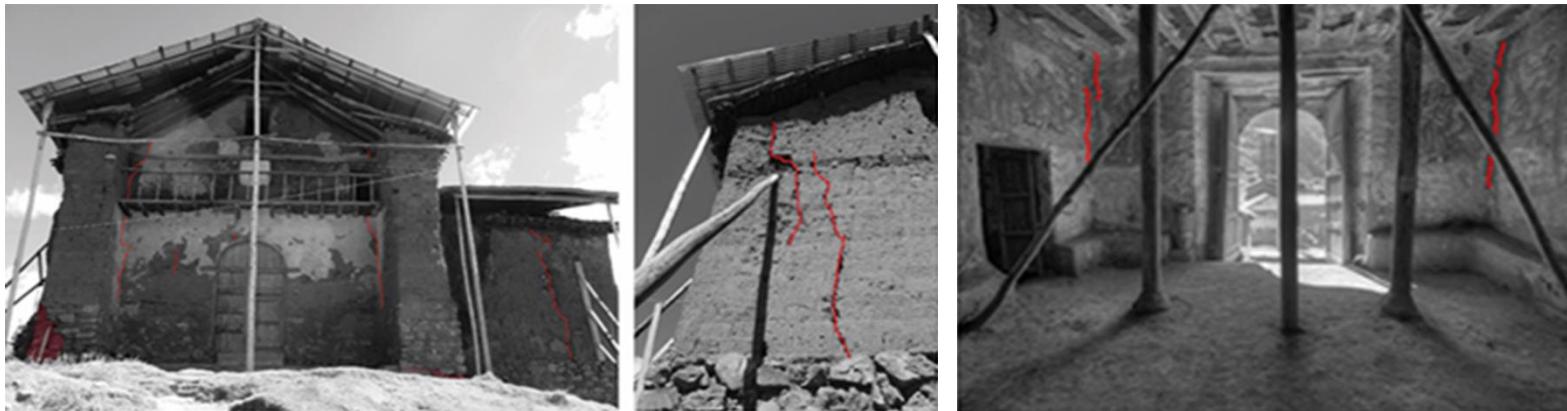
Existing damage

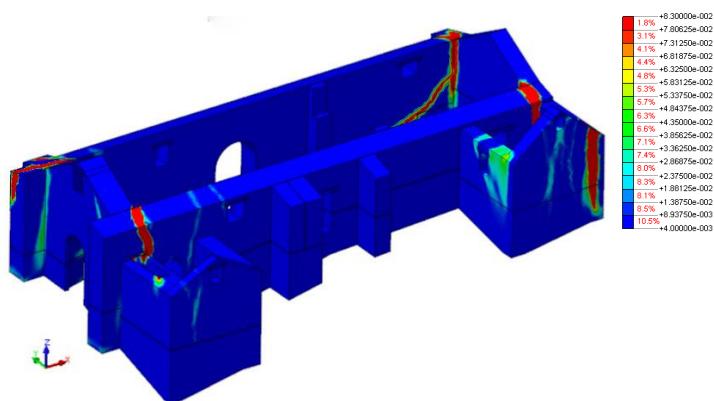
Pushover analysis - Max principal strains superposition

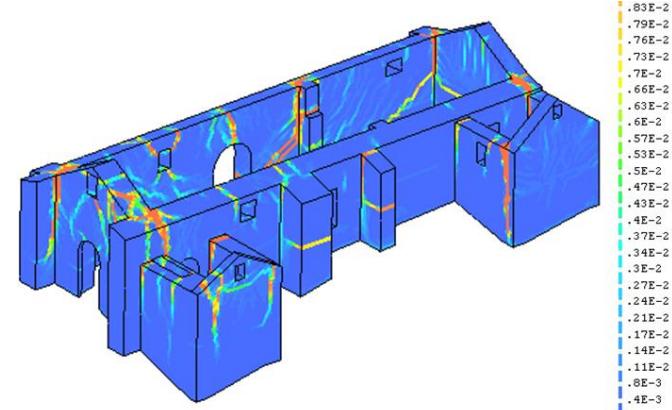
Time History analysis - Max principal strains

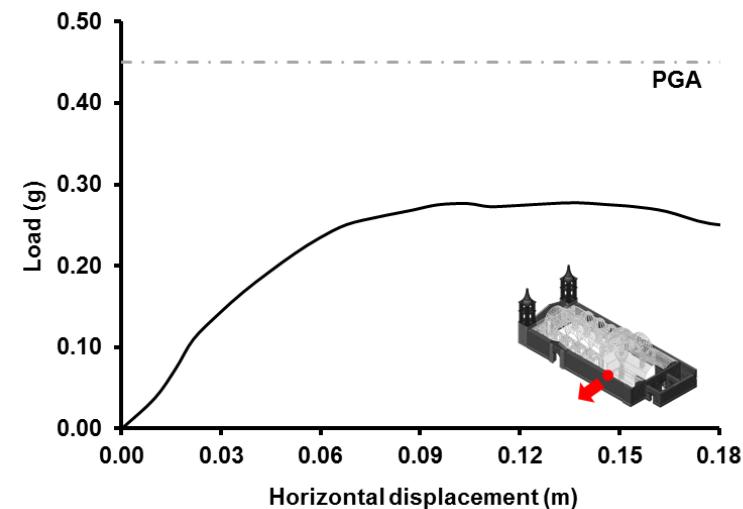
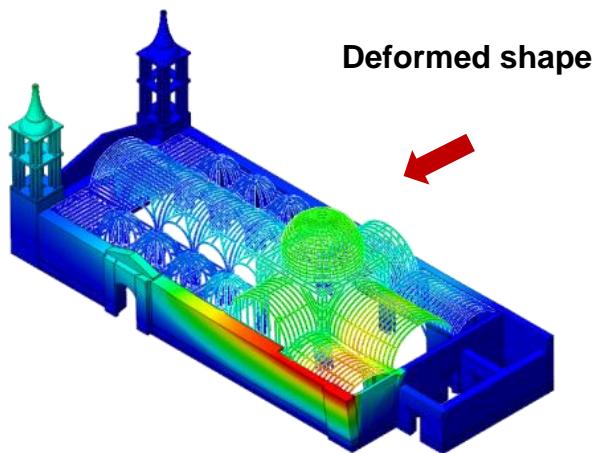
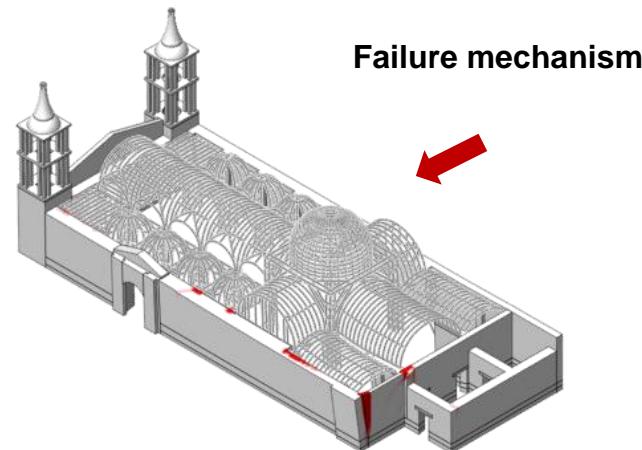
## Pushover analysis (IC)

- Minimum seismic capacity of **0.28g**, much lower than the design PGA (0.45g)
- Out-of-plane mechanism of the **northern lateral wall**

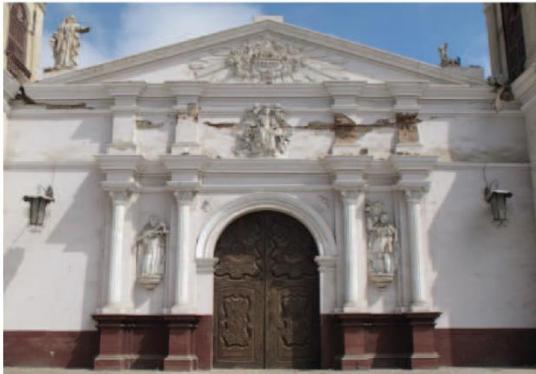
Existing Damage

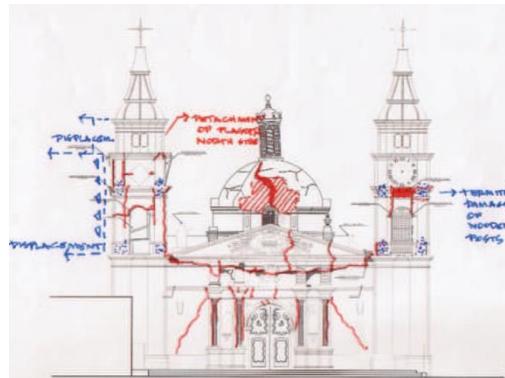
In-situ damage survey (Cancino et al, 2015)

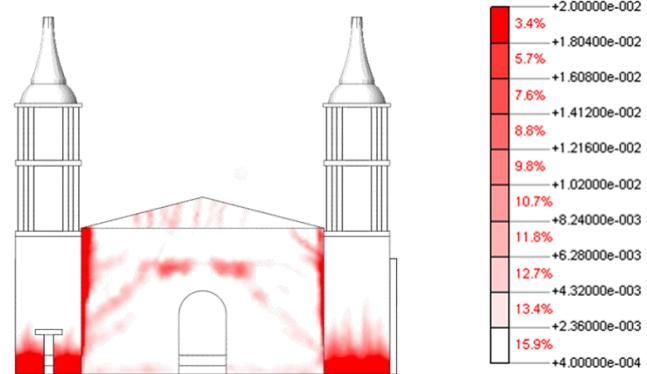
Pushover Analysis - Max Principal Strains

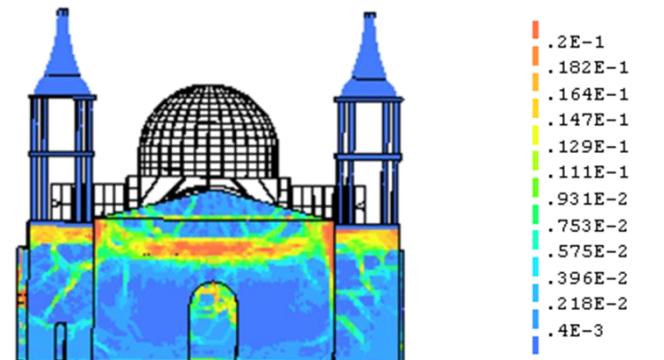
Time History Analysis - Max Principal Strains

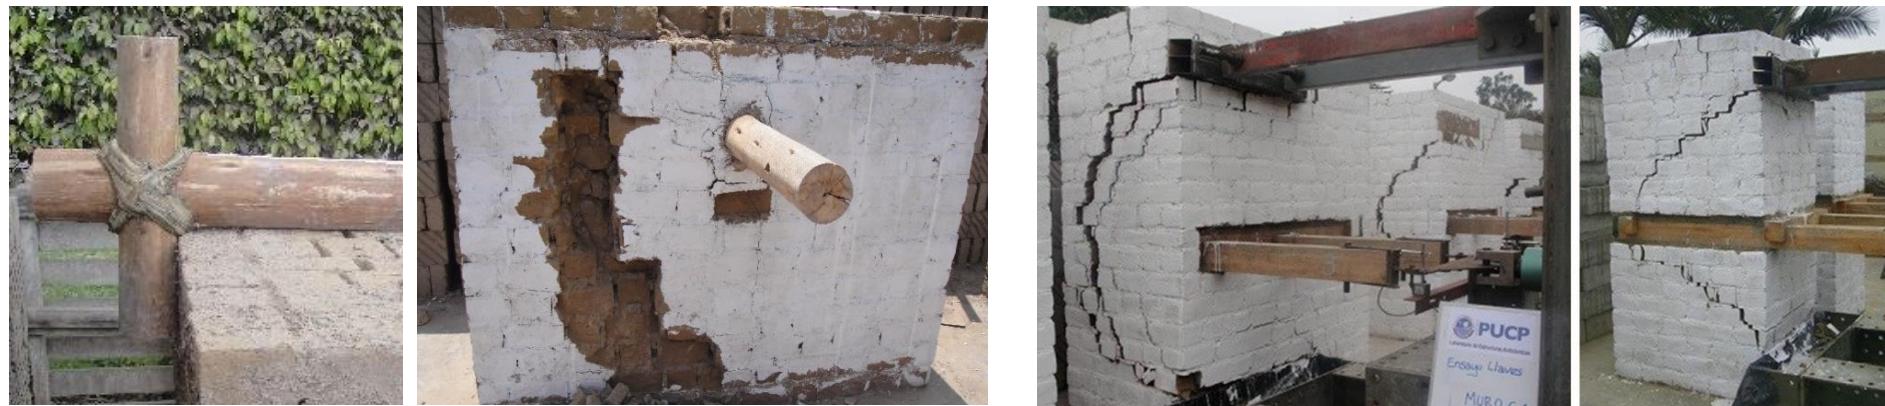
- **Bracing elements** (corner keys, horizontal keys, bond beams and anchored tie beams)
  - To improve the connection between **walls**, **wall-to-floor** and **wall-to-roof connections**
  - Located at **various levels**, involving mostly the upper parts
  - **Confinement in masonry** and **friction** or **shear action**

Experimental results on pull-out tests from PUCP

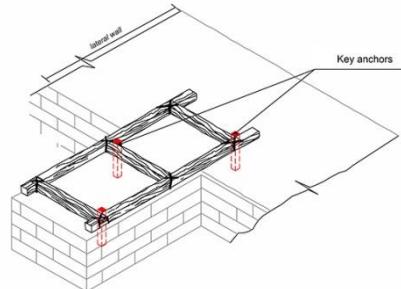
Horizontal timber key between buttress and adjoining wall. Vertical key anchors to enhance connectivity

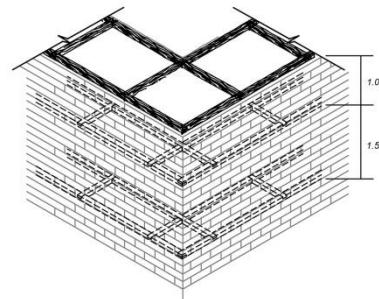
Timber embedded corner keys in elevation. Continuous bond beam at top

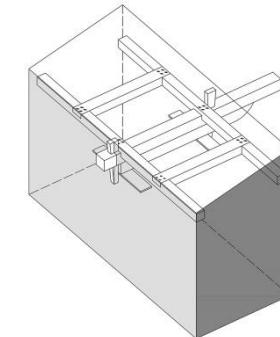
Bond beam, tie beam and vertical timber anchors

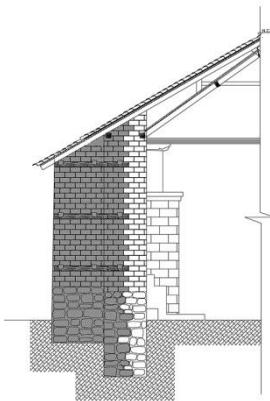
New buttress with horizontal timber keys and interlocking, and geo-mesh, lower part of stabilized adobe (replaced by brick masonry during execution)

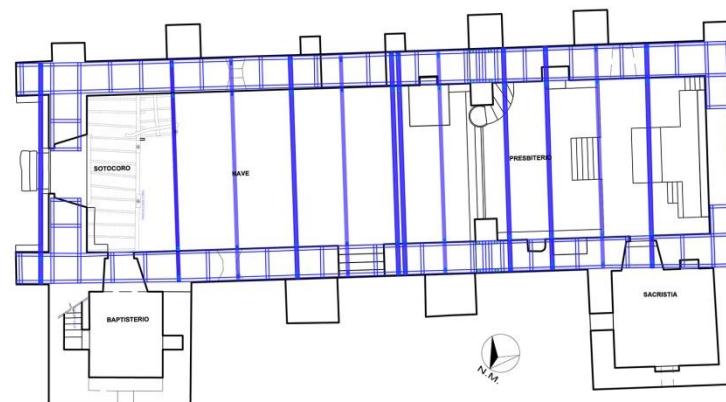
Bond-beam at top eaves. Configuration with two longitudinal timber beams and transversal timber blockers. Connection with tie beams

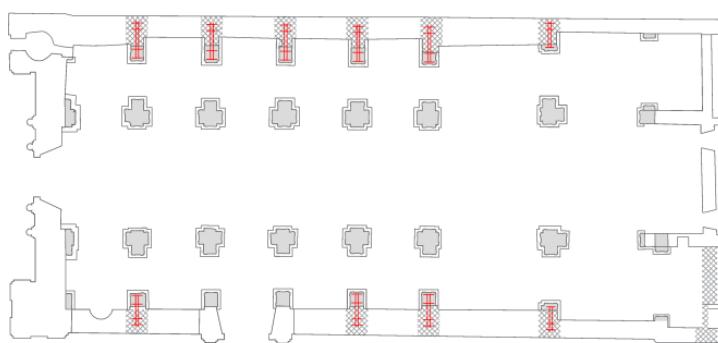
Timber anchoring system at the lower levels

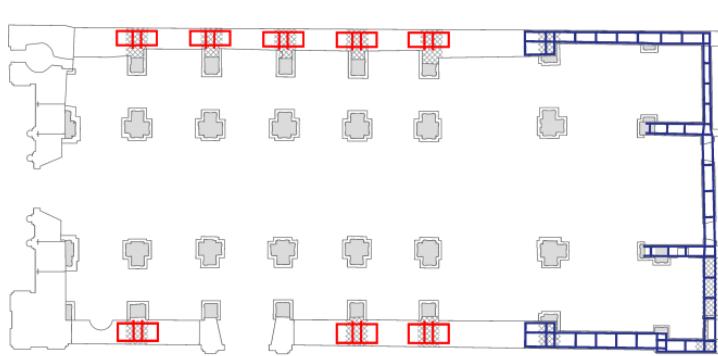
Timber anchoring system at the upper level

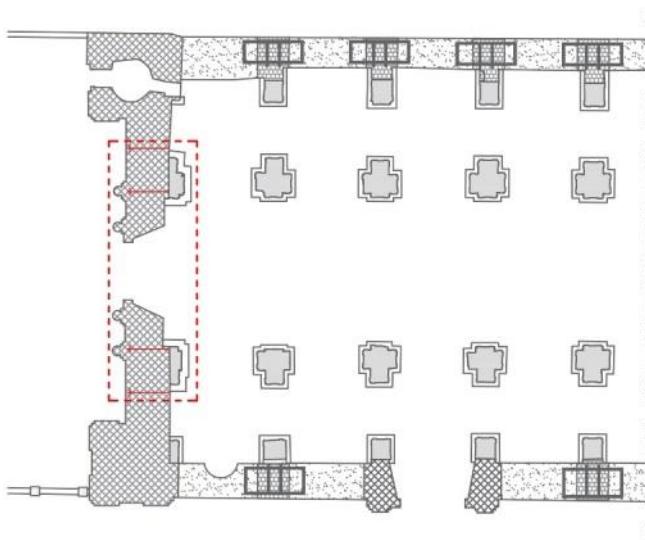
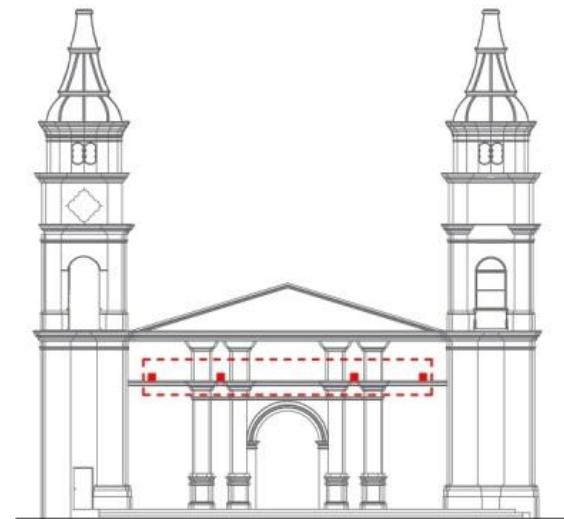
## □ Bracing elements (IC)

Steel anchoring system at the main façade

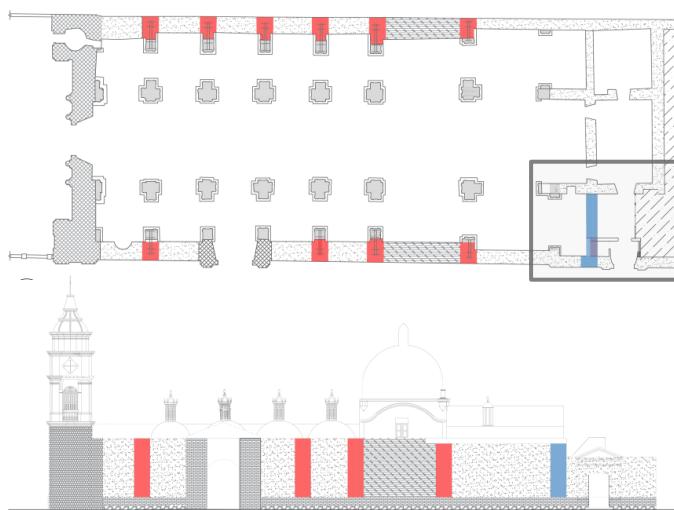
## □ Consolidation

- To enhance **integrity** and to ensure **limited long-term deterioration**
- Replacement of selected parts, **as limited as possible**
- **Interlocking** between old and new masonry

Replacement

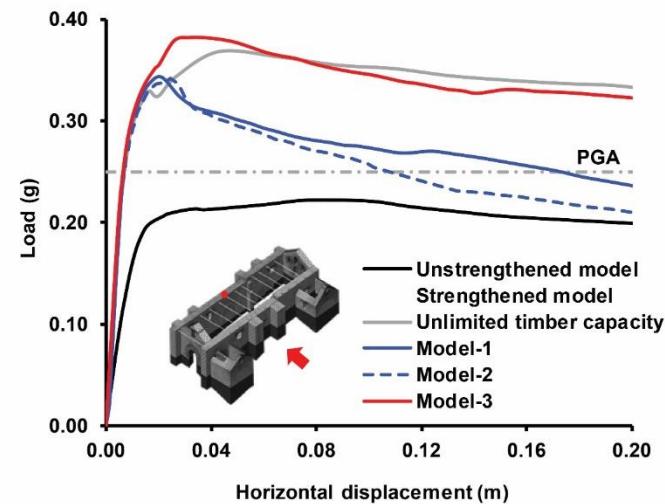
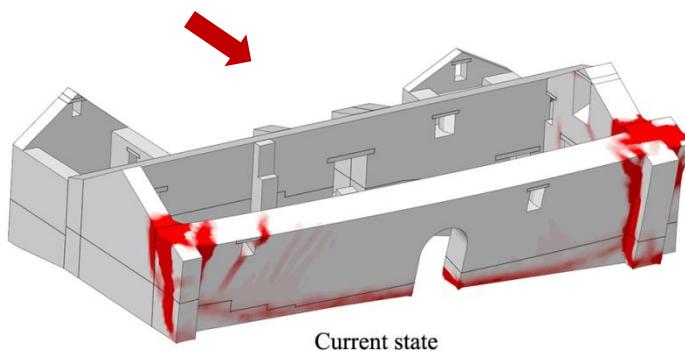
## Pushover analysis (KT)

- Seismic capacity of **0.34g**, higher than the design PGA
- Out-of-plane bending mechanism, with more masonry involved
- Damage widely spread, with smaller crack width

Failure mechanism in terms of tensile strains
