# **Technologies for Seismic Retrofitting and Strengthening of Earthen and Masonry Structures: Assessment and Application**

**Paulo B. Lourenço**

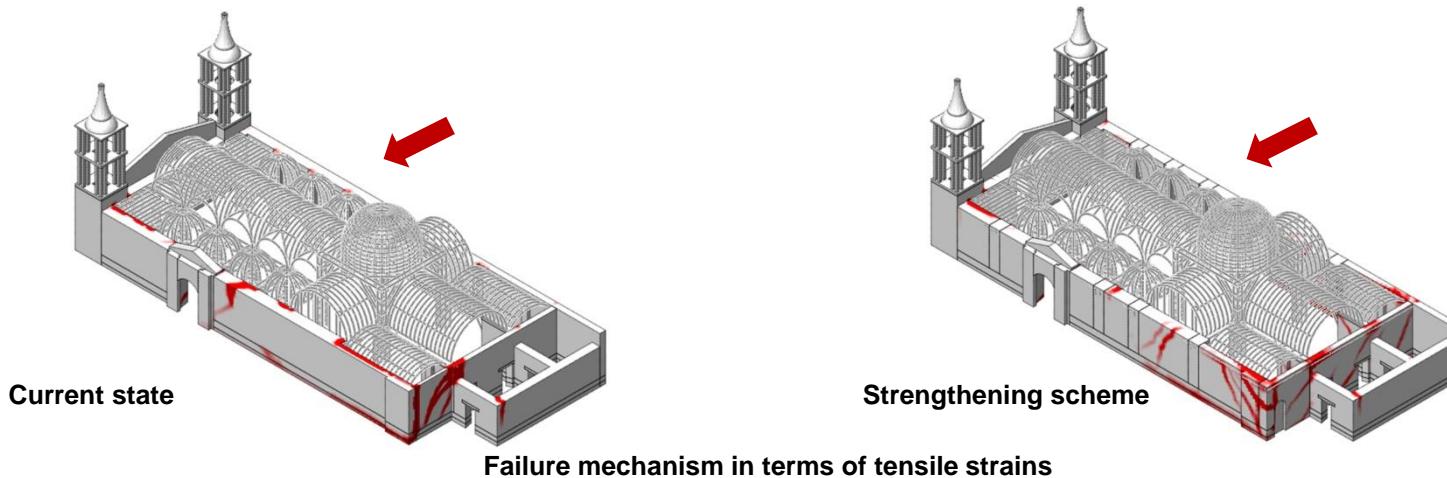
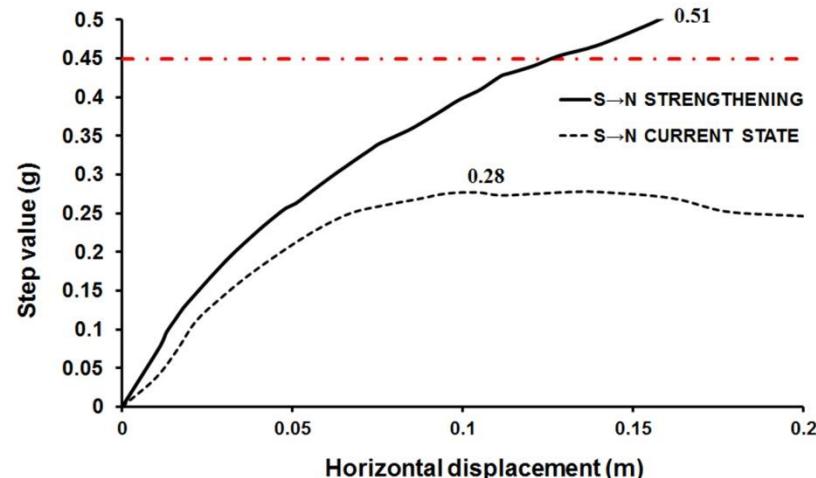
## Pushover analysis (IC)

- Seismic capacity higher than the design PGA (**0.45g**)
- Out-of-plane bending mechanism, activating both the longitudinal walls
- Damage more distributed in the north-west corner

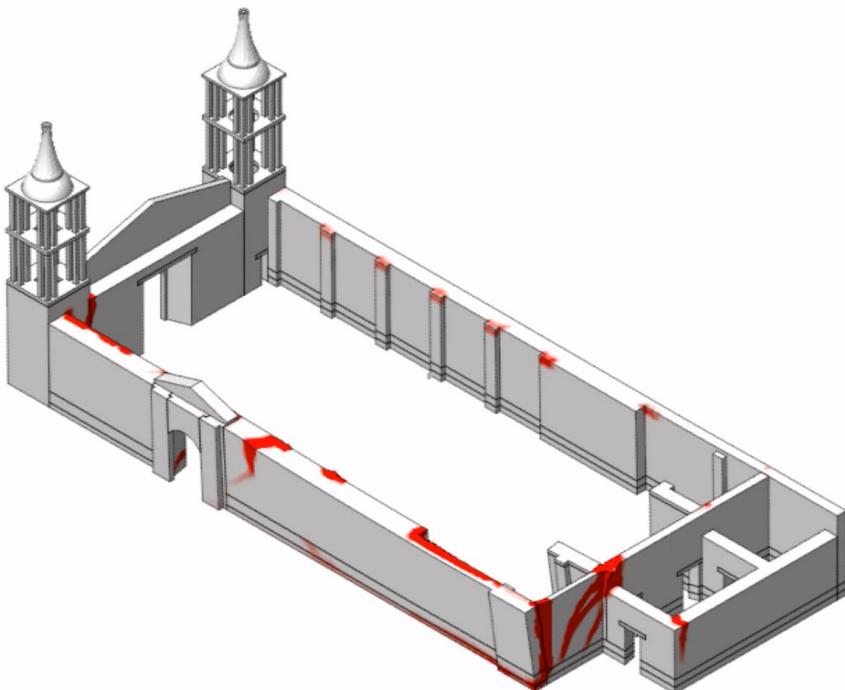
# Pushover analysis (IC)

**Non-strengthened**

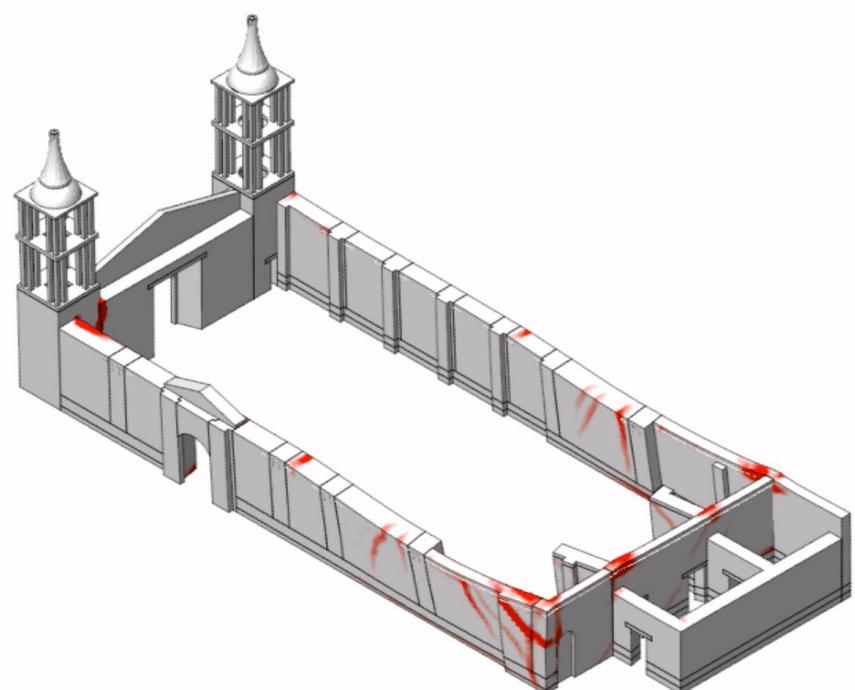
**Strengthened**
